**DEPARTMENT OF TRANSPORTATION****DIVISION OF ENGINEERING SERVICES**

Contract #: 04-0120F4Cty: SF/ALA Rte: 80 PM: 13.2/13.9File #: 69.28**WELDING INSPECTION REPORT****Resident Engineer:**Pursell, Gary**Address:** 333 Burma Road**City:** Oakland, CA 94607**Report No:** WIR-005709**Date Inspected:** 04-Mar-2009**Project Name:** SAS Superstructure**OSM Arrival Time:** 645**Prime Contractor:** American Bridge/Fluor Enterprises, a JV**OSM Departure Time:** 1845**Contractor:** Zhenhua Port Machinery Company, Ltd (ZPMC), Changxing Island **Location:** Shanghai, China**CWI Name:** Shen Fu You**CWI Present:** Yes No**Inspected CWI report:** Yes No N/A**Rod Oven in Use:** Yes No N/A**Electrode to specification:** Yes No N/A**Weld Procedures Followed:** Yes No N/A**Qualified Welders:** Yes No N/A**Verified Joint Fit-up:** Yes No N/A**Approved Drawings:** Yes No N/A**Approved WPS:** Yes No N/A**Delayed / Cancelled:** Yes No N/A**Bridge No:** 34-0006**Component:** OBG**Summary of Items Observed:**

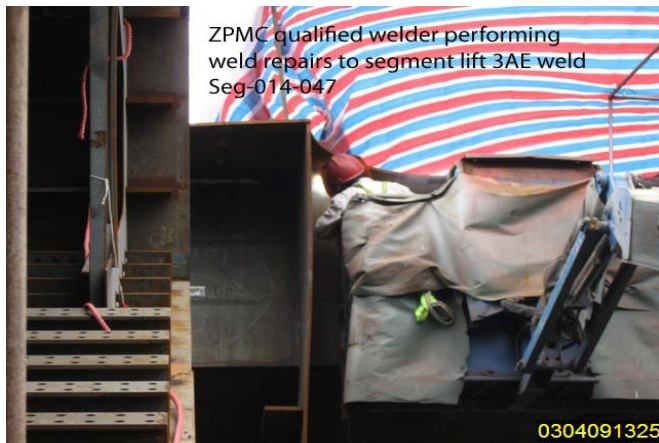
inspection verification on panel point 26 and the outside top, sides, and bottom of lift. QA Inspector performed visual verification on segment and marked seventeen (17) indications throughout segment for repair. ABF QC Inspector and ZPMC QC concurred with QA Inspectors findings and marked indication areas themselves. QA Inspector performed a third (3) visual inspection verification of segment welds and base material after ZPMC and ABF QC Inspection. QA Inspector found segment welds and base material appear to meet the requirements of the contract documents and AWS D1.5 (02).
